Re: **Approved Jurisdictional Determinations, U. S. Army Corp of Engineers Permit SPL-2008-00816**

**RE: Rosemont Mine Approved Jurisdictional Determination, U. S. Army Corp of Engineers Permit SPL-2008-00816**

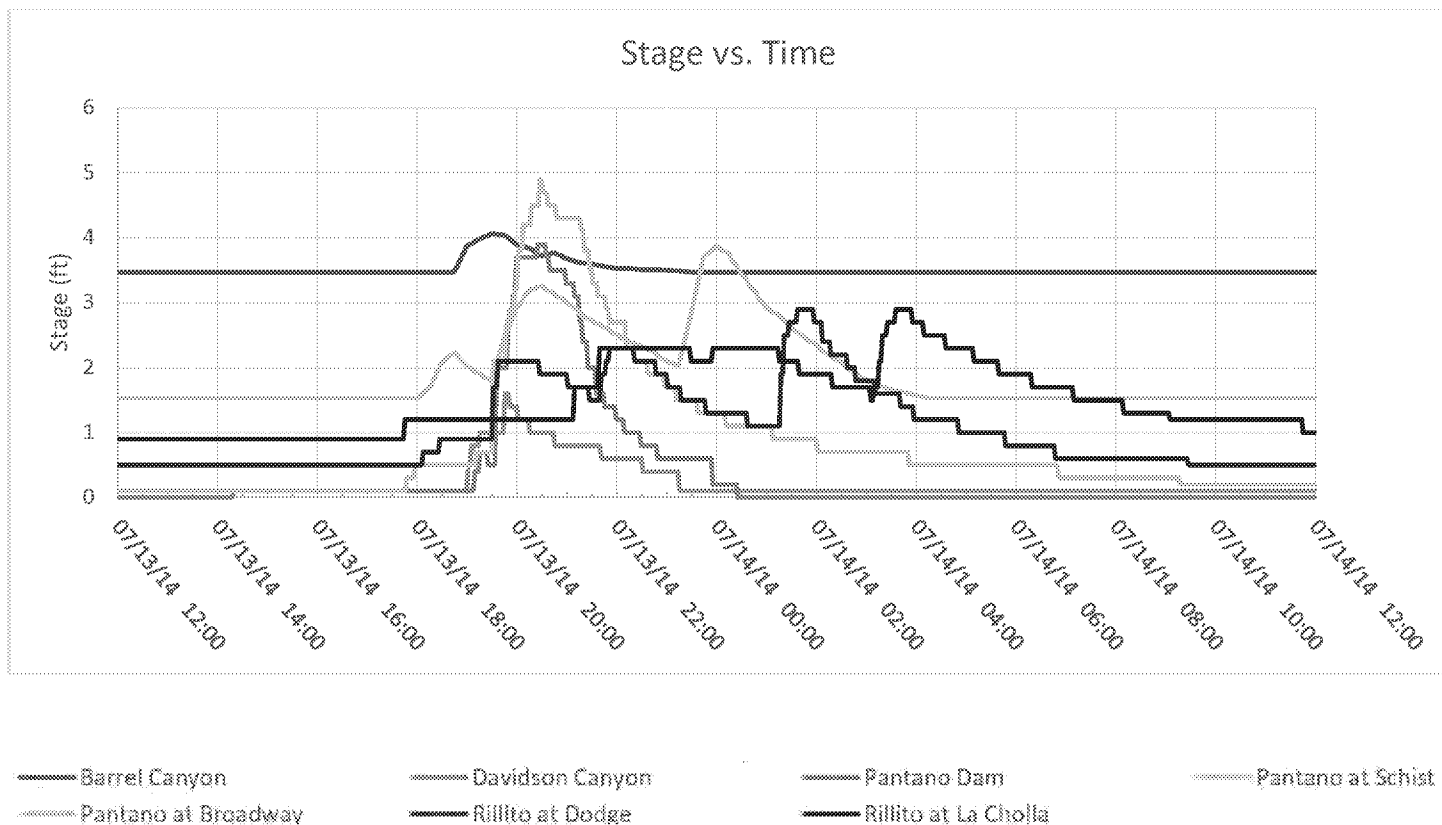
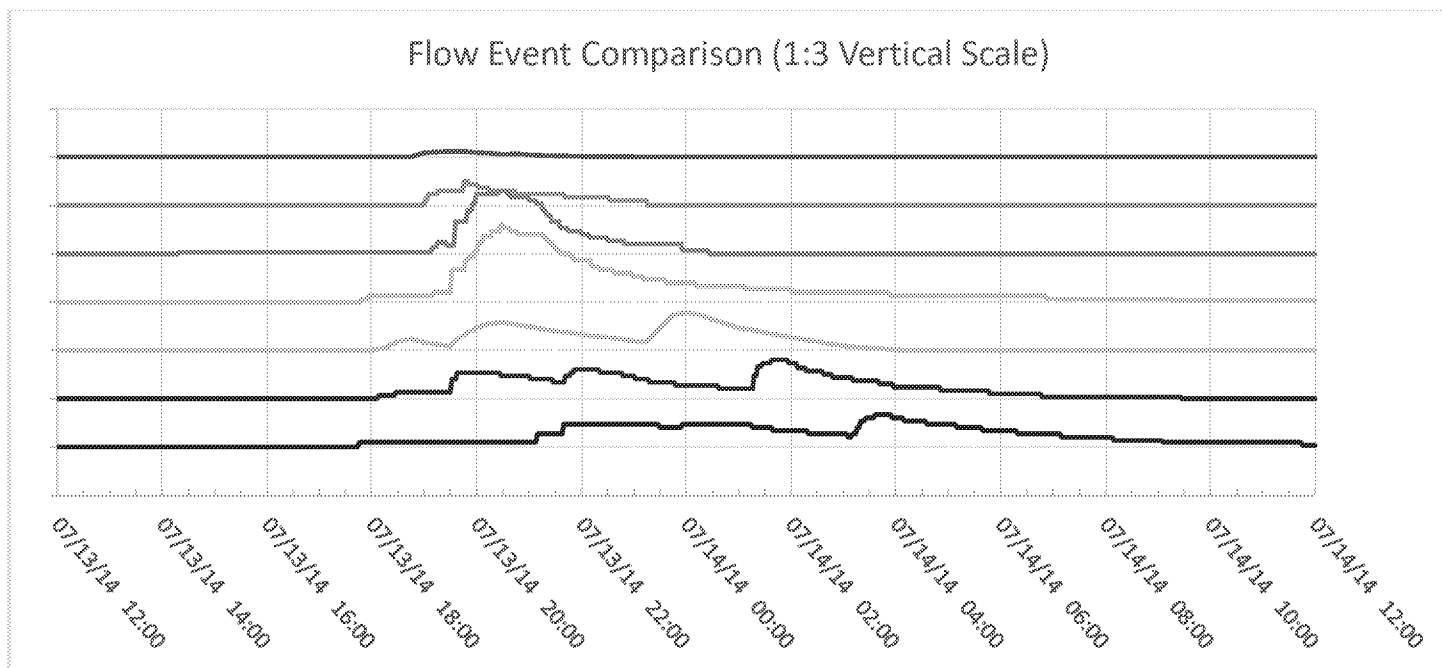
13 July 2014

24-hour Qualitative Precipitation Estimate: Recorded at 5:00 AM 7/14/2014

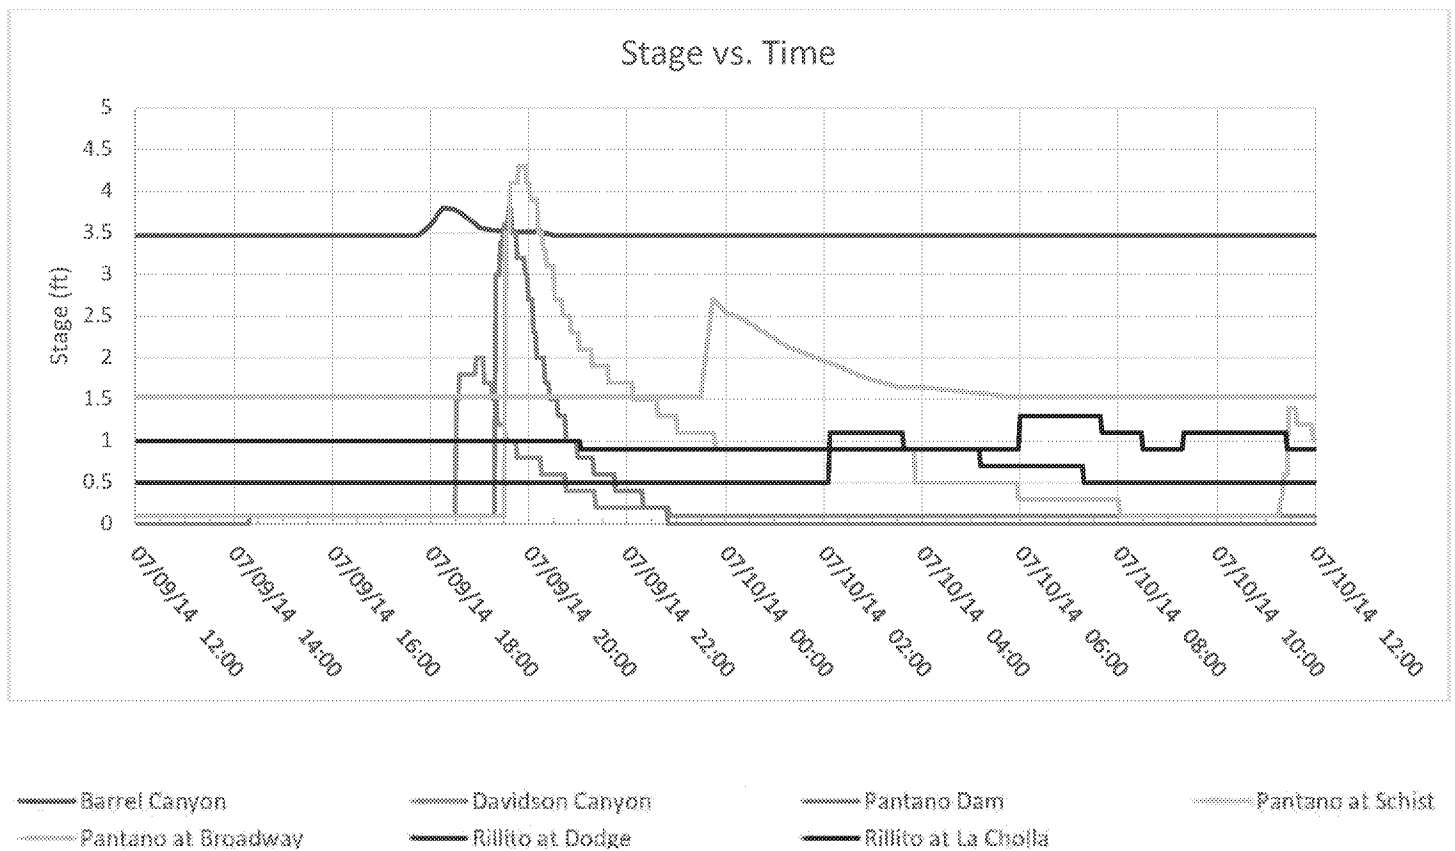
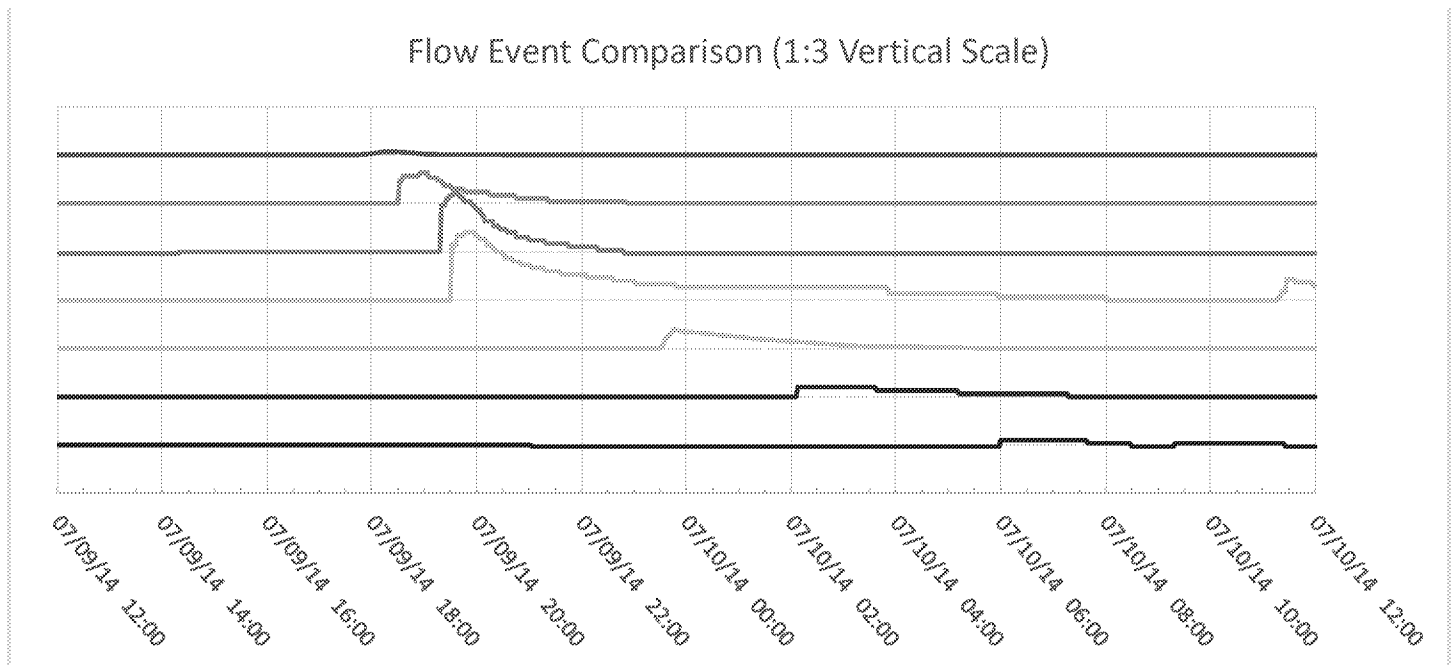
9 July 2014

24-hour Qualitative Precipitation Estimate: Recorded at 5:00 AM 7/10/14
